**Bioventing Pilot Test Work Plan for
Areas H and K, and Site 2
Hickam AFB, Hawaii**

**Draft Interim Pilot Test Results Report for
Areas H and K, and Site 2
Hickam AFB, Hawaii**

Engineering-Science, Inc.

August 1993

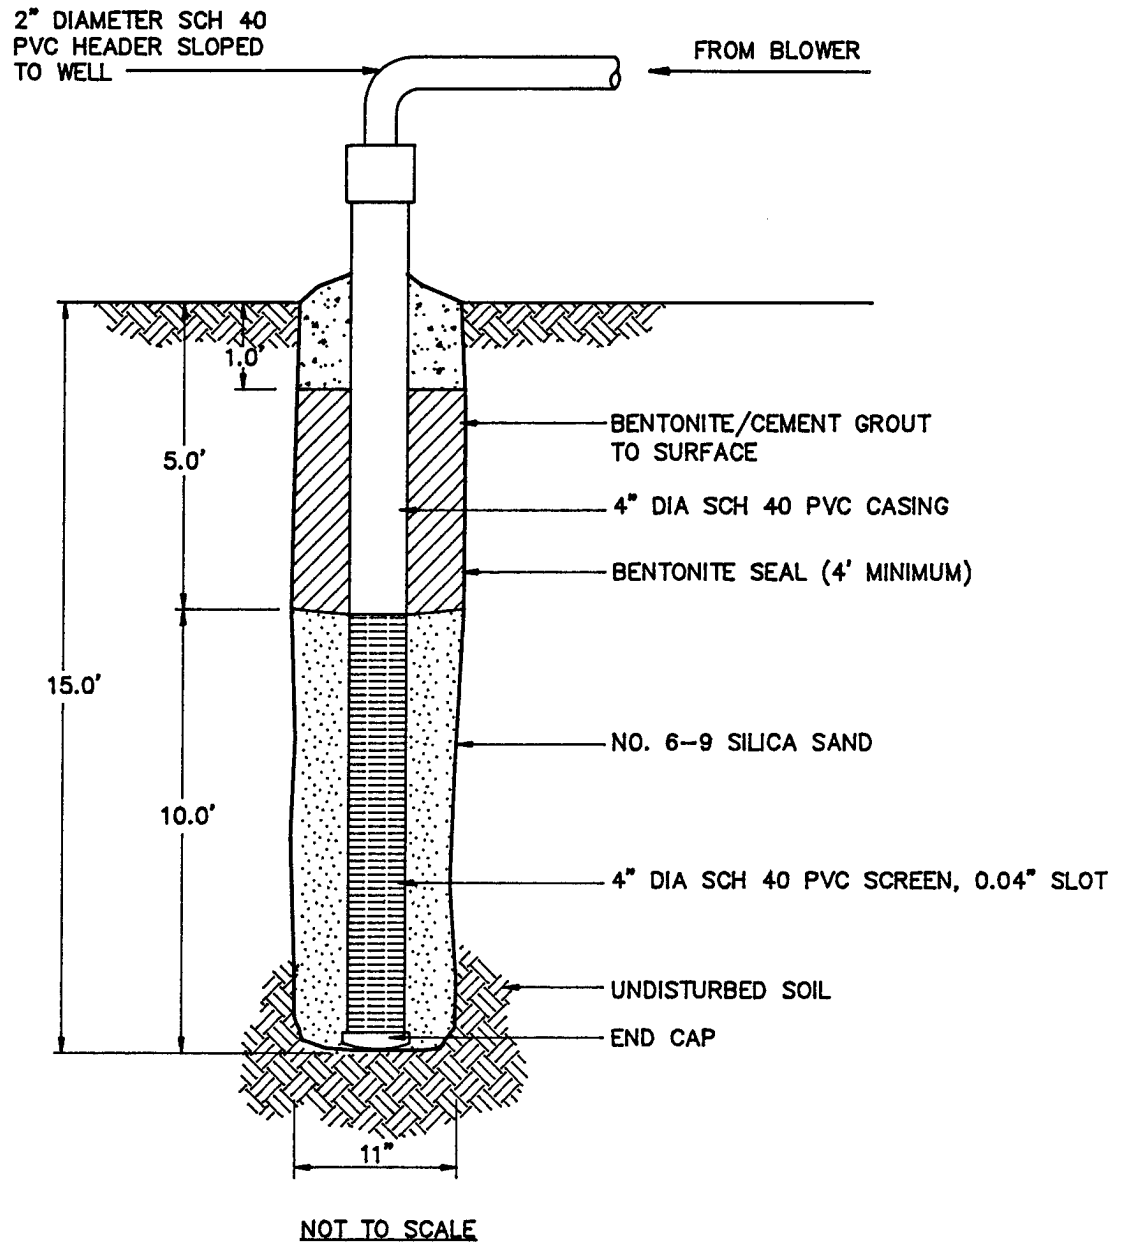
FIGURE 3.2
AREA H
AIR INJECTION VENT WELL
CONSTRUCTION DETAIL

The VW will be located approximately 3 feet east of the recovery well enclosure. The VW will be constructed of 4-inch inside diameter (ID) Schedule 40 polyvinyl chloride (PVC), with a 10-foot interval of 0.04-inch slotted screen set at 5 to 15 feet bgs. Flush-threaded PVC casing and screen with no organic solvents or glues will be used. The filter pack will be clean, well rounded silica sand with a 6-9 grain size and will be placed in the annular space of the screened interval. A 4-foot layer of bentonite will be placed directly over the filter pack. The first 6 inches of bentonite will consist of bentonite pellets hydrated in place with potable water. This layer of pellets will prevent the addition of bentonite slurry from saturating the filter pack. The remaining 42 inches of bentonite will be fully hydrated and mixed aboveground, and the slurry will be tremied into the annular space to produce an air-tight seal above the screened interval. A complete surface seal is necessary in order to prevent injected air from short circuiting to the surface during the bioventing test. Figure 3.2 illustrates the proposed VW construction for this site.

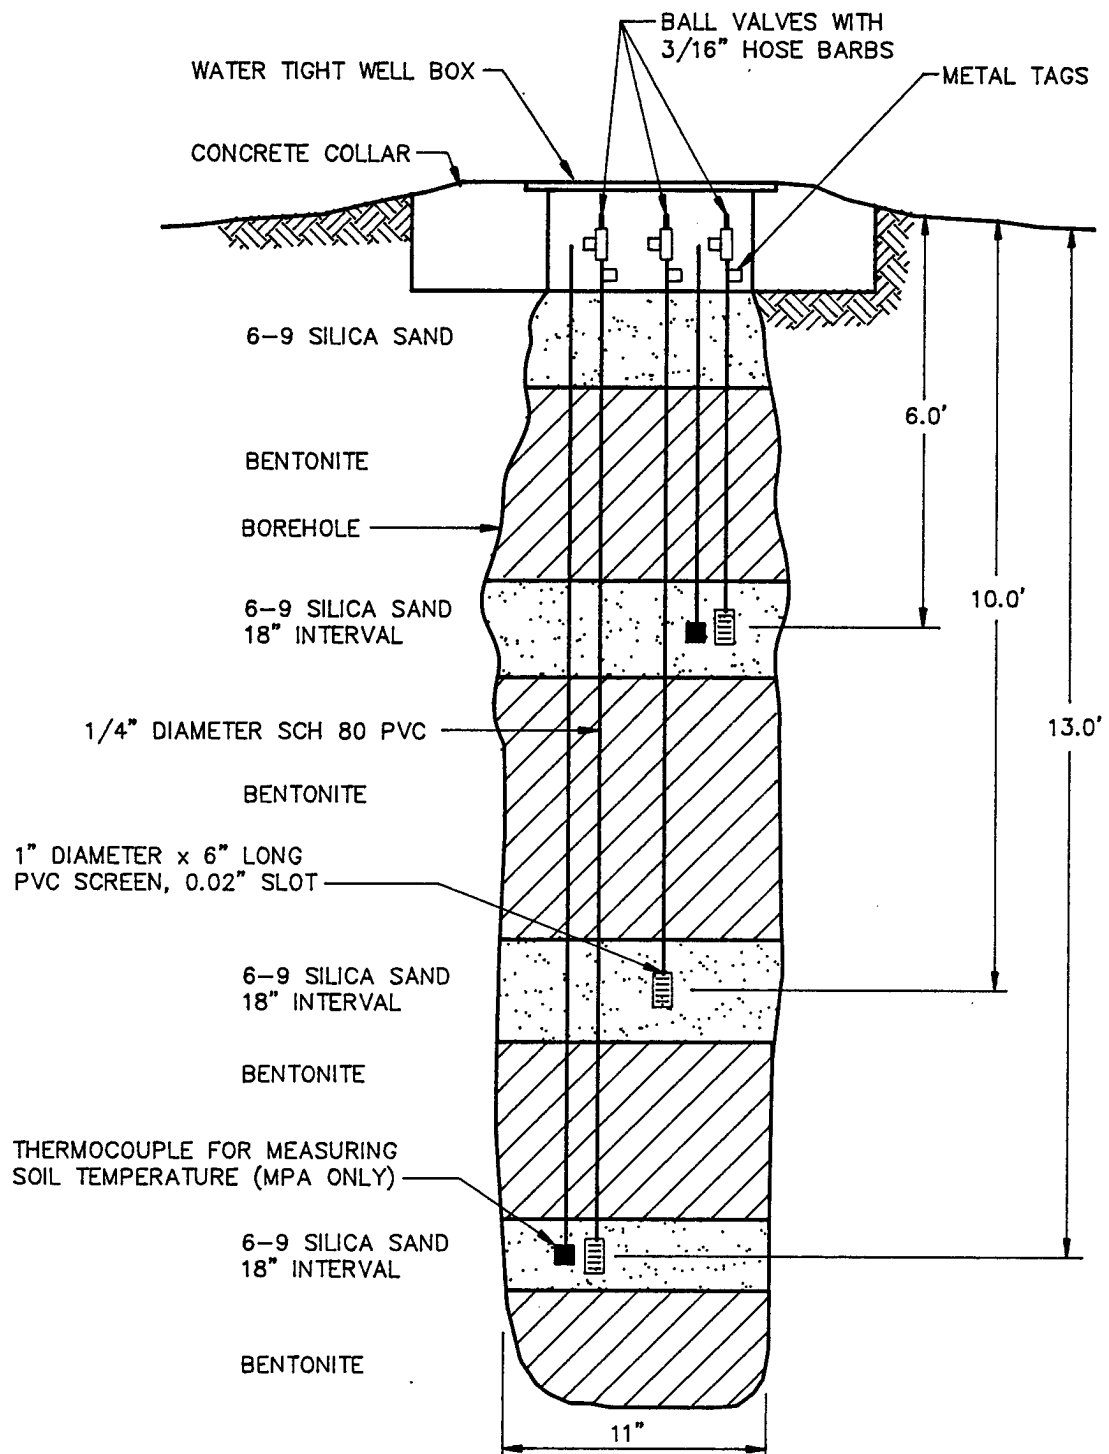
FIGURE 3.3

A typical multi-depth vapor MP installation design for this site is shown in Figure 3.3. Soil gas oxygen and carbon dioxide concentrations will be monitored at a depth intervals of 6 feet, 10 feet and 13 feet at each location. Multi-depth monitoring will confirm that the entire soil profile is receiving oxygen, and be used to measure fuel biodegradation rates at each depth. The spaces between monitoring intervals will be sealed with bentonite to isolate the intervals. As with the central VW, several inches of bentonite pellets will be used to shield the filter pack from rapid

AREA H
MONITORING POINT
CONSTRUCTION DETAIL

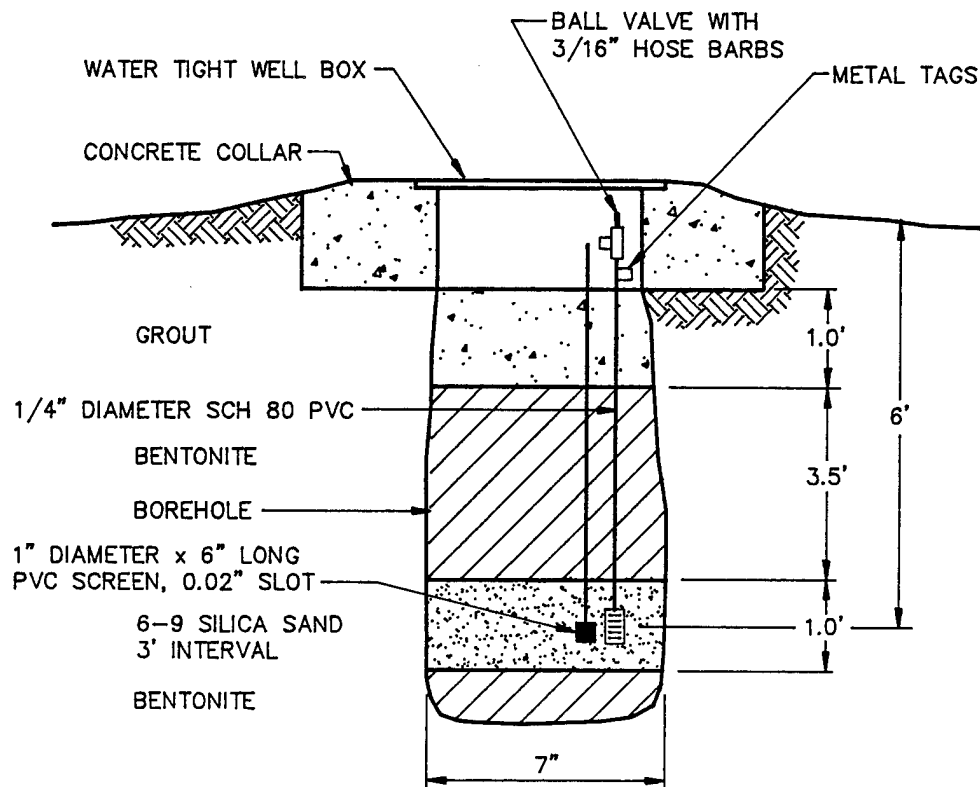
FIGURE 3.6

A typical vapor MP installation design for this site is shown in Figure 3.6. Soil gas oxygen and carbon dioxide concentrations will be monitored at a depth of approximately 6 feet at each location. The exact depth of each MP will be determined based on the interval of highest soil contamination. As with the central VW, several inches of bentonite pellets will be used to shield the filter pack from rapid infiltration of bentonite slurry additions.

AREA K
MONITORING POINT
CONSTRUCTION DETAIL

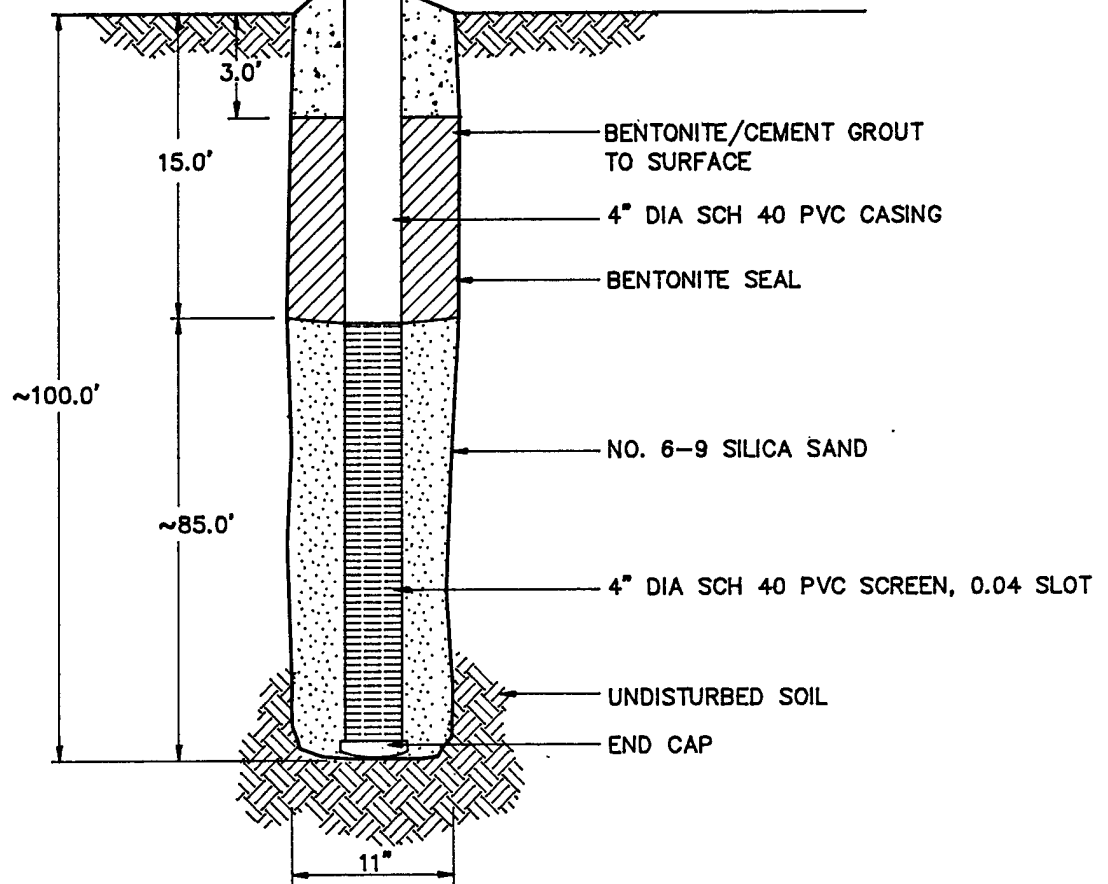
FIGURE 3.8

2" DIAMETER SCH 40
PVC HEADER SLOPED
TO WELL

FROM BLOWER

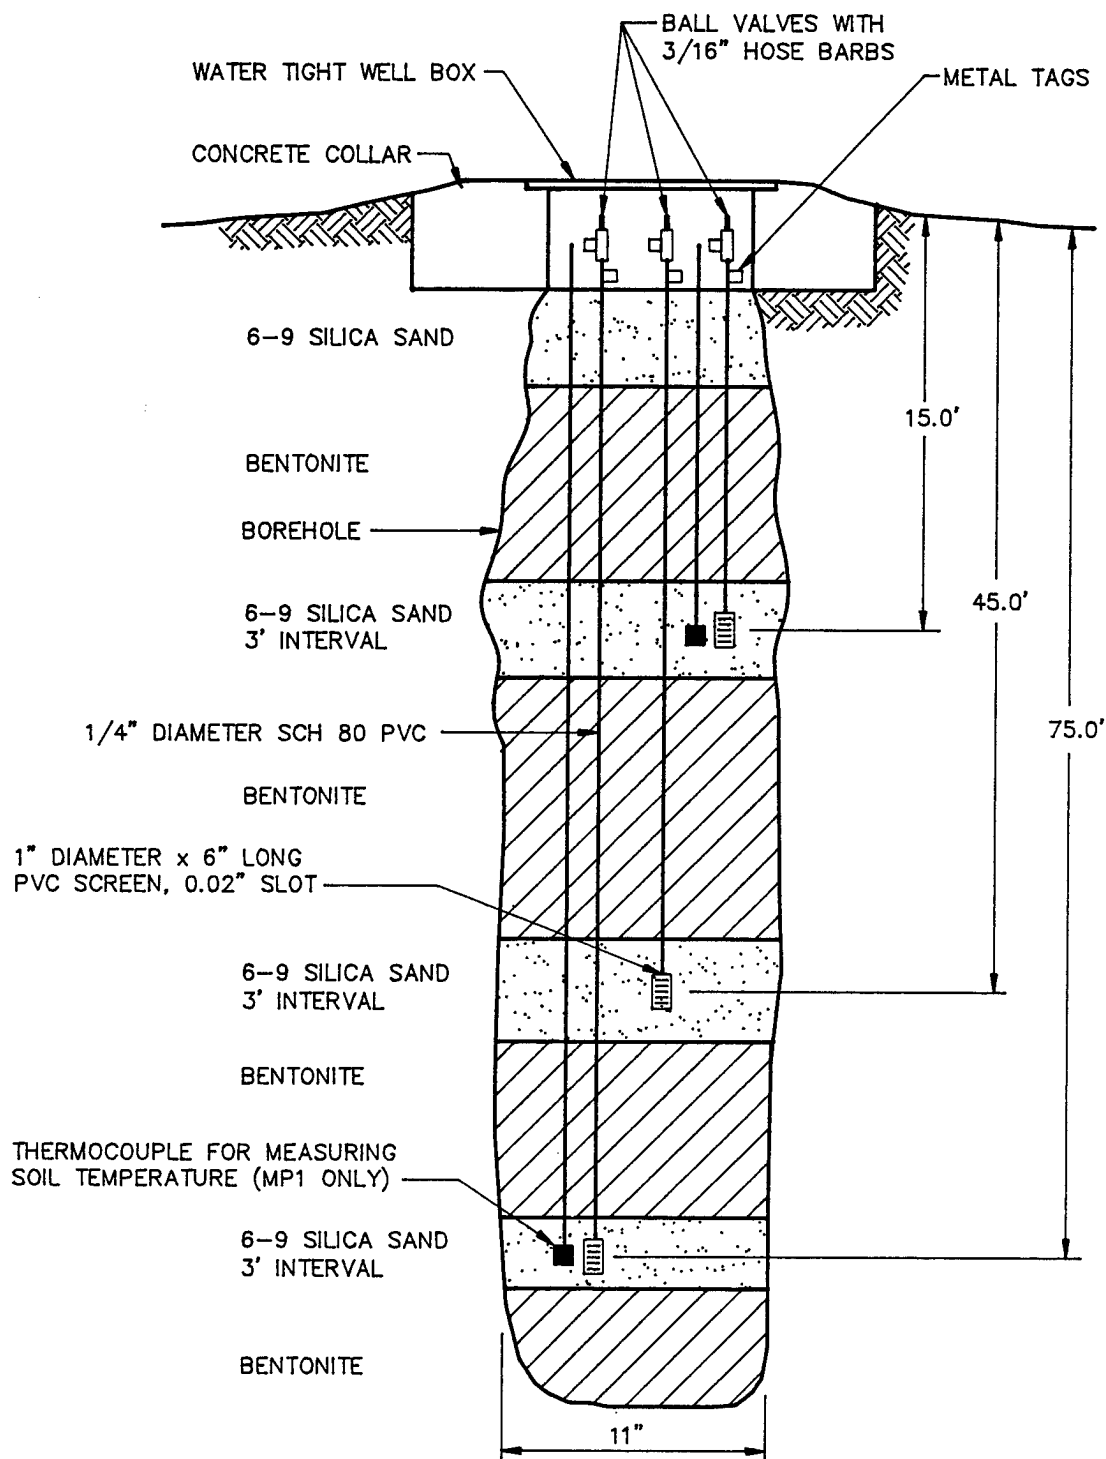
FIGURE 3.9

A typical multi-depth vapor MP installation for this site is shown in Figure 3.9. Soil gas oxygen and carbon dioxide concentrations will be monitored at approximate depth intervals of 15 feet, 45 feet, and 75 feet at each location. Multi-depth monitoring will confirm that the entire soil profile is receiving oxygen, and be used to measure fuel biodegradation rates at all depths. The spaces between monitoring intervals will be sealed with bentonite to isolate the intervals. As with the central VW, several inches of bentonite pellets will be used to shield the filter pack from rapid infiltration of bentonite slurry additions. Additional details on VW and MP construction can be found in Section 4 of the protocol document.

**SITE 2
MONITORING POINT
CONSTRUCTION DETAIL**

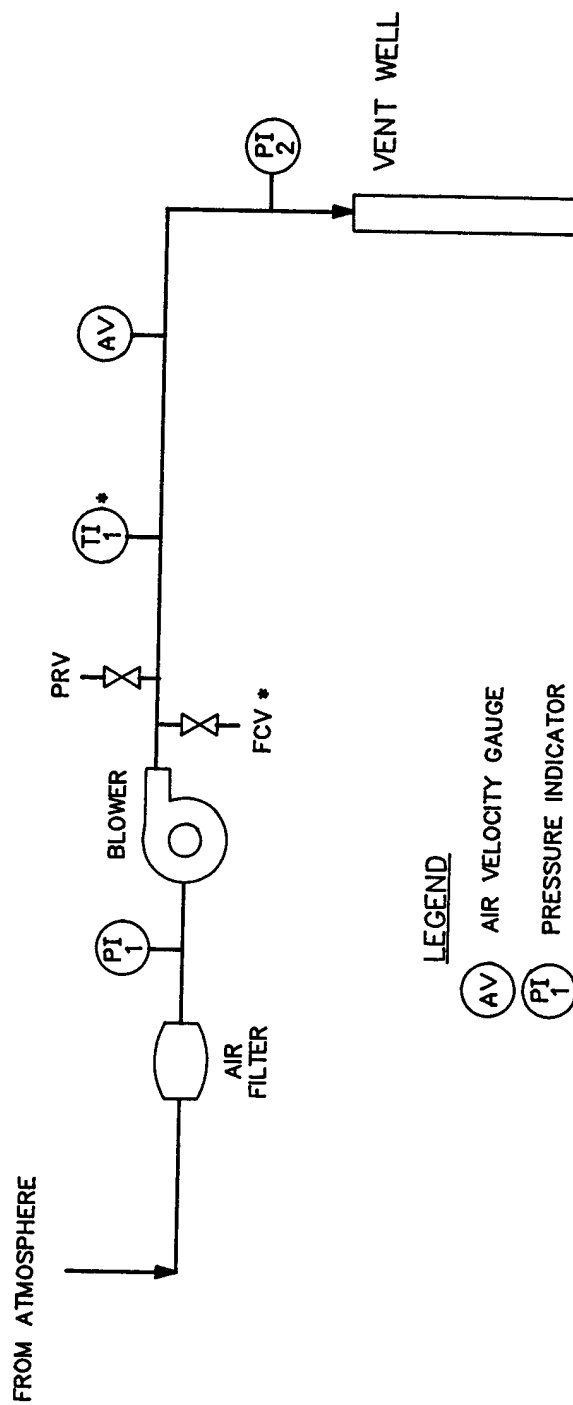
- (AV) AIR VELOCITY GAUGE
- (PI₁) PRESSURE INDICATOR
- (TI₁) TEMPERATURE INDICATOR
- FCV FLOW CONTROL VALVE
- PRV PRESSURE RELIEF VALVE
- * OPTIONAL

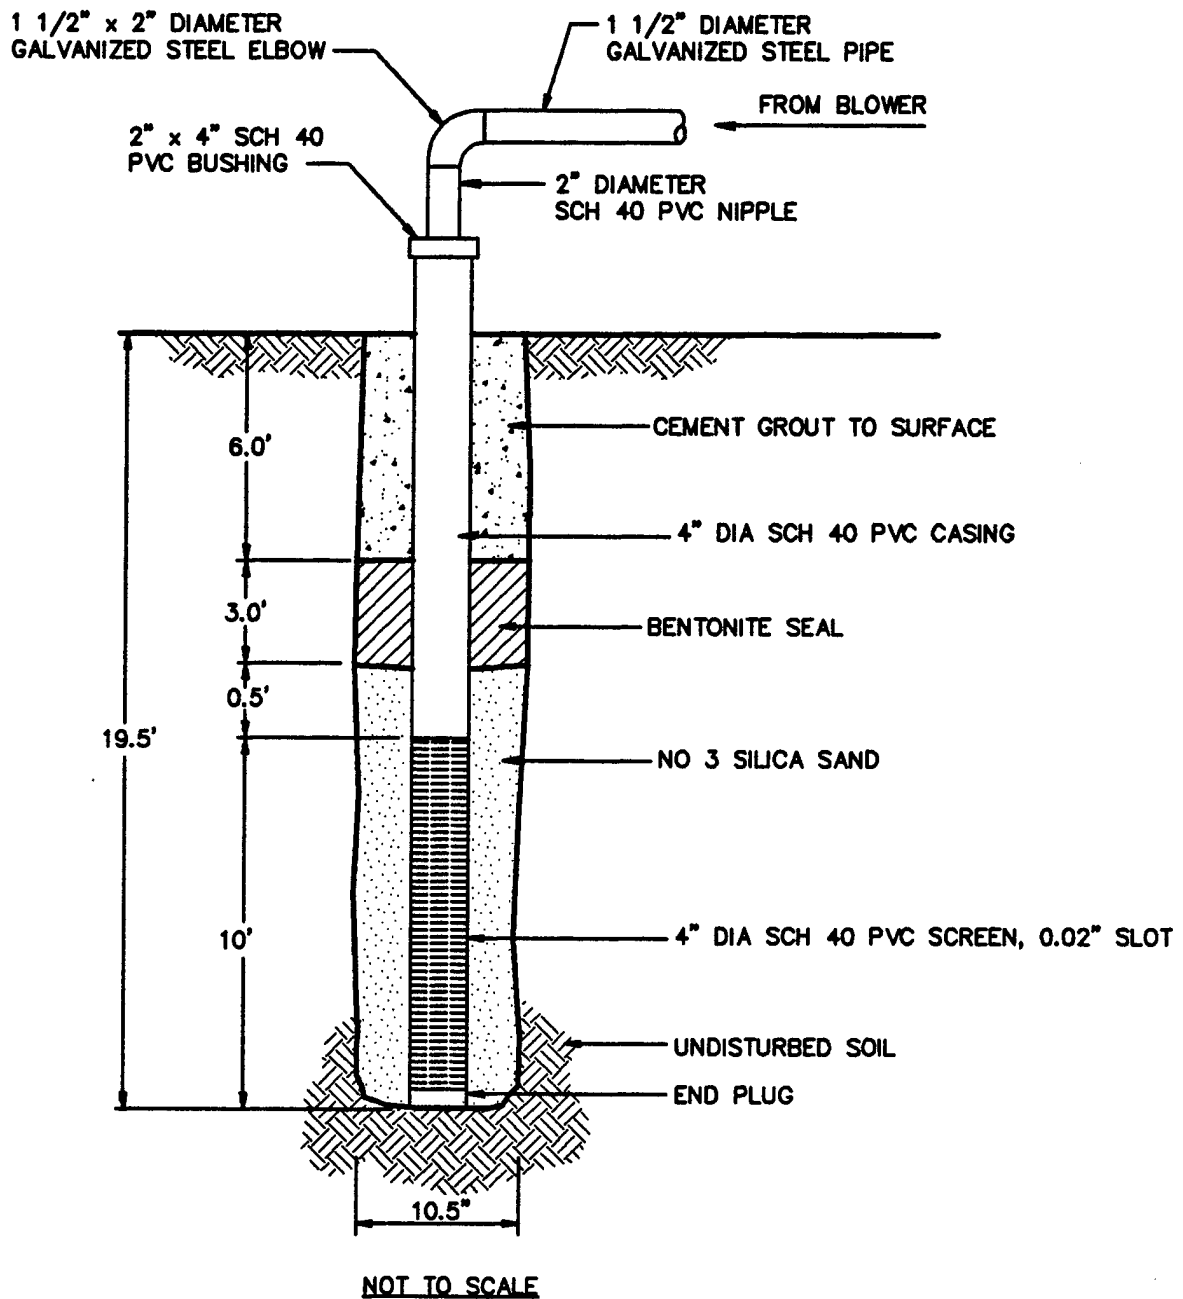
FIGURE 1.3

The air injection VW was installed following procedures described in the Air Force Center for Environmental Excellence (AFCEE) bioventing protocol document (Hinchee et al., 1992). Figure 1.3 shows construction details for the VW. The VW was installed in silt/sandstone and clayey sand that contained hydrocarbon contamination below 18 feet bgs. Groundwater was encountered 20 feet bgs. The VW was constructed using 4-inch-diameter, Schedule 40 polyvinyl chloride (PVC) casing, with 10 feet of 0.02-inch slotted PVC screen installed from 9.5 to 19.5 feet bgs. The annular space between the well casing and borehole was filled with number 3 silica sand from the bottom of the borehole to approximately 6 inches above the well screen. Approximately 3 feet of granular bentonite was placed above the sand in 6-inch lifts, with each lift being hydrated in place. On top of the bentonite layer, approximately 6 feet of cement grout was placed and was finished flush with the existing grass surface. The well casing was cut off approximately 6 inches above the surface, and the casing was connected to a galvanized steel header using a rubber pipe coupler.

AREA H
AS-BUILT INJECTION VENT WELL
CONSTRUCTION DETAIL

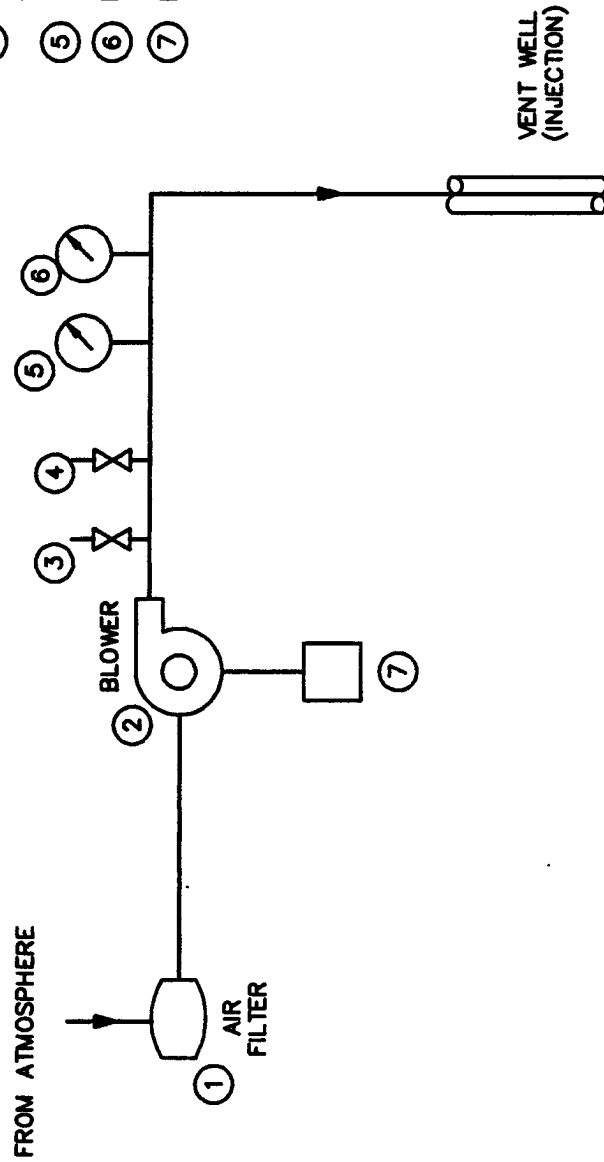
FIGURE 1.5

For both the initial and extended pilot tests, a 1.5-horsepower Gast® model 2567-P102 rotary-vane blower unit was used. During the initial air permeability test, the unit was energized by 230-volt, single-phase, 20-amp power from a temporary exterior receptacle. The fixed unit is energized by 230-volt, single-phase, 20-amp line power from a newly installed underground power line and aboveground breaker installed by base electricians. The configuration, instrumentation, and specifications for this blower system are shown on Figure 1.5. The blower is currently transporting air at a flow rate of approximately 19 actual cubic feet per minute (acfm) for the extended pilot test. After blower installation and startup, ES engineers provided an operation and maintenance (O&M) manual, including maintenance instructions, equipment specifications, and monitoring forms, to base personnel. A copy of the O&M instructions is provided in Appendix A.

- ① INLET AIR FILTER - GAST®MODEL AA 905G
- ② 1 1/2 HORSEPOWER ROTARY VANE BLOWER - GAST®MODEL 2567-P102
- ③ AUTOMATIC PRESSURE RELIEF VALVE - GAST®MODEL AA307
- ④ MANUAL PRESSURE RELIEF (BLEED) VALVE 3/4" GATE
- ⑤ TEMPERATURE GAUGE (0-250° F)
- ⑥ PRESSURE GAUGE (0-10 psi)
- ⑦ DISCONNECT SWITCH - 230V/SINGLE PHASE/20 AMP

AREA H AS-BUILT BLOWER SYSTEM FOR AIR INJECTION

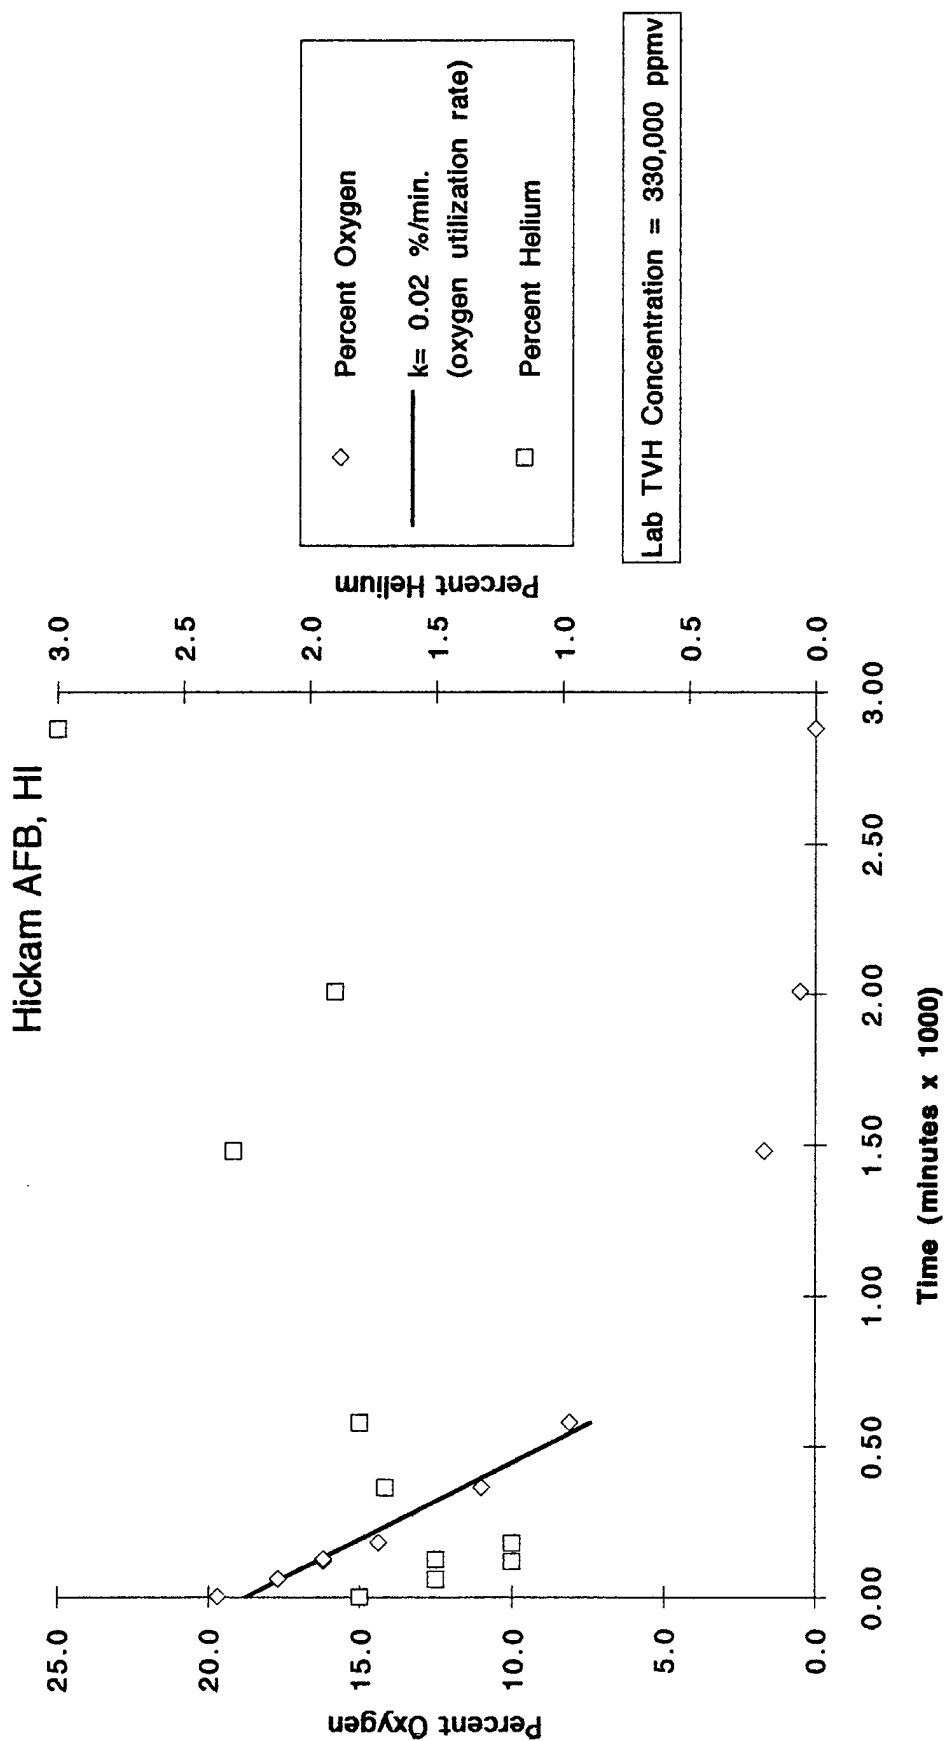
Figure 1.6
Respiration Test
Oxygen and Helium Concentrations
Area H
VW
Hickam AFB, HI

At the VW and MPC-12.4, the oxygen utilization rates appear to decrease over time (Figures 1.6 and 1.8). This apparent decrease has been observed at other shallow fuel spill sites, where an oxygen source is in close proximity to contaminated soils. Although much of the rock in the vadose zone seems to be highly impermeable, atmospheric oxygen could diffuse into the subsurface through fractures in the rock. As oxygen is rapidly consumed by fuel-degrading bacteria in deeper contaminated soils, the oxygen diffusion gradient between the contaminated soil and the atmosphere becomes substantial. As a result, oxygen begins to diffuse from the atmosphere into the contaminated soils. This inward oxygen diffusion temporarily masks the actual bacterial oxygen uptake rates. Because fuel biodegradation generally consumes oxygen at a rate that exceeds diffusion, the oxygen concentrations soon return to zero in contaminated soils.

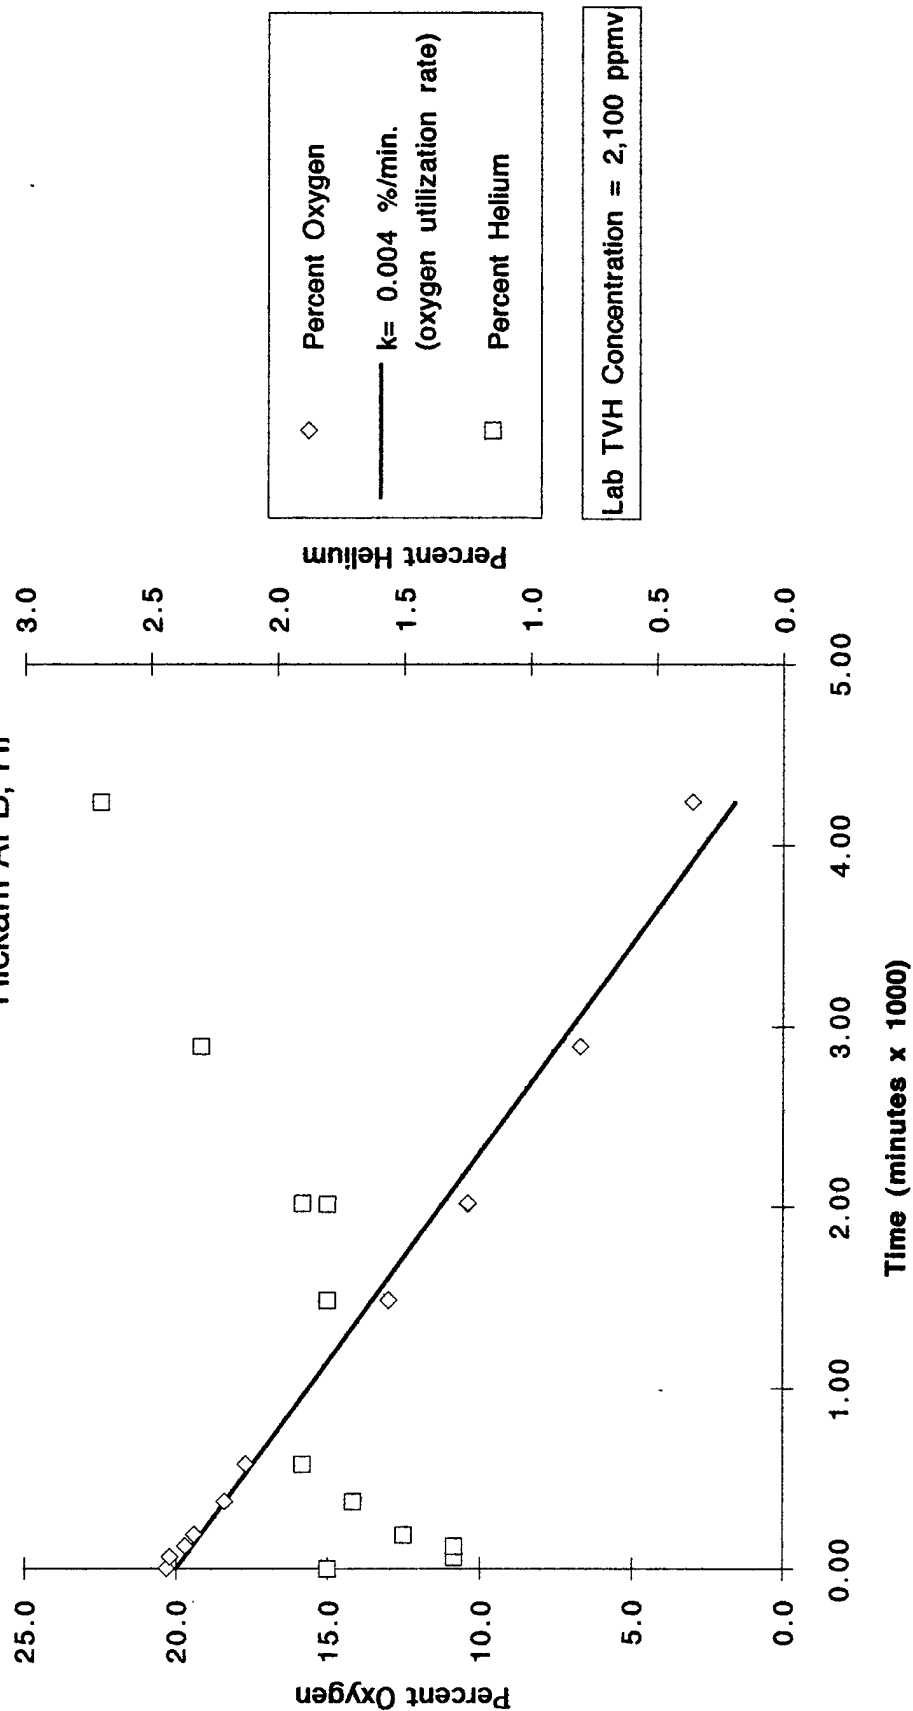
Figure 1.7
Respiration Test
Oxygen and Helium Concentrations
Area H
MPA-6
Hickam AFB, HI

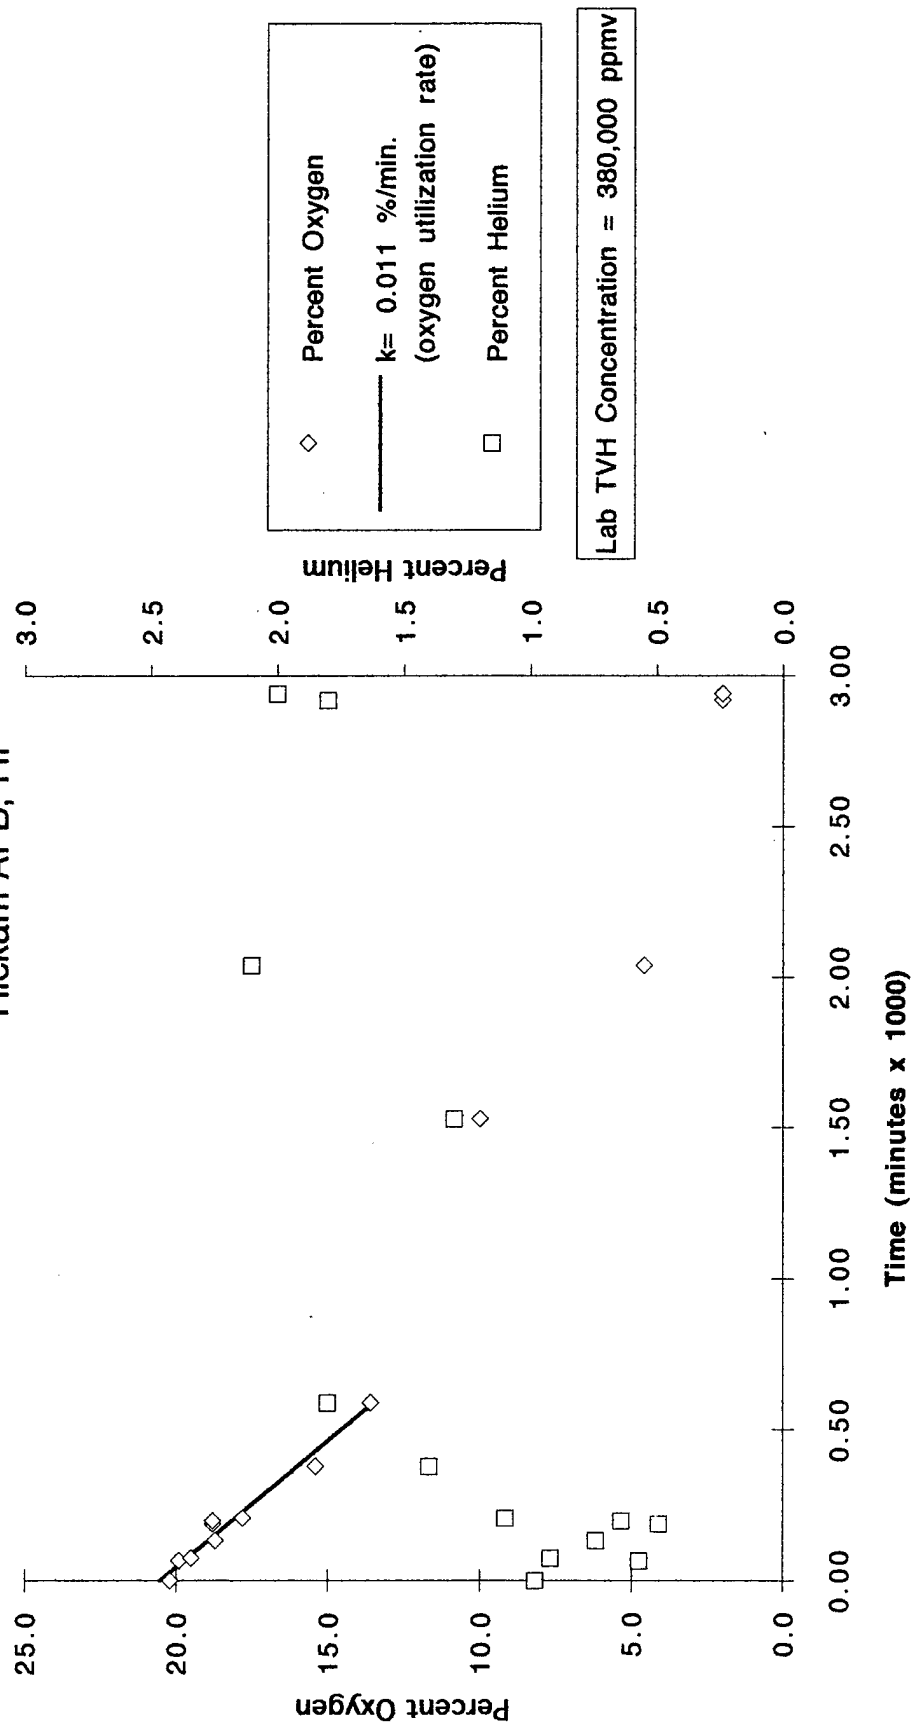
Figure 1.8
Respiration Test
Oxygen and Helium Concentrations
Area H
MPC-12.4
Hickam AFB, HI

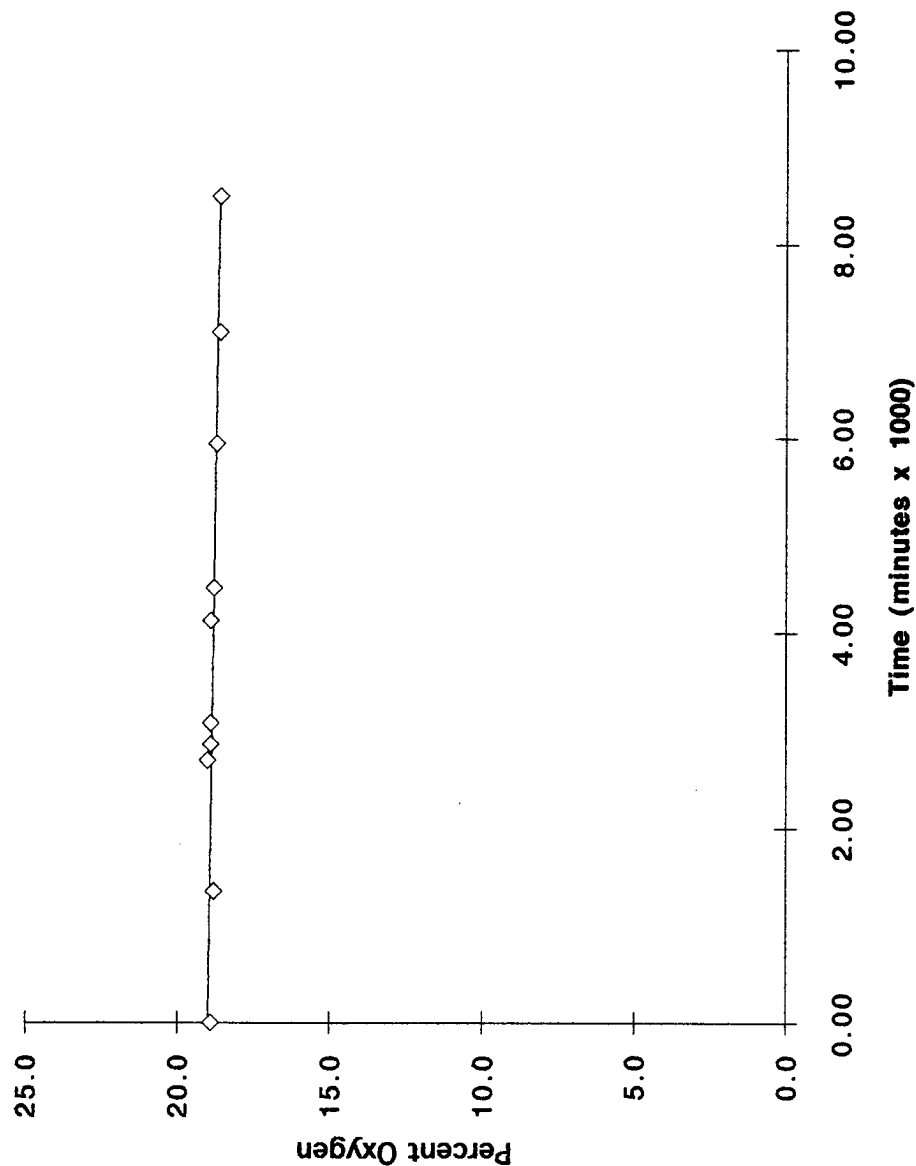
Figure 1.9
Oxygen Concentrations at BG Soil Gas Probe HI-BG
Hickam AFB, HI

Oxygen concentrations were monitored over time at background soil gas probe HI-BG to quantify respiration rates in uncontaminated soil (Figure 1.9). No air or helium injection was conducted at HI-BG. A comparison of the oxygen utilization rate at HI-BG [0.00004 percent per minute (%/min)] with the average of the oxygen utilization rates at the VW, MPA-6, and MPC-12.4 (0.012 %/min) demonstrates that the oxygen is being utilized by soil bacteria at Area H for the biodegradation of petroleum hydrocarbons rather than the consumption of naturally occurring soil organic matter.

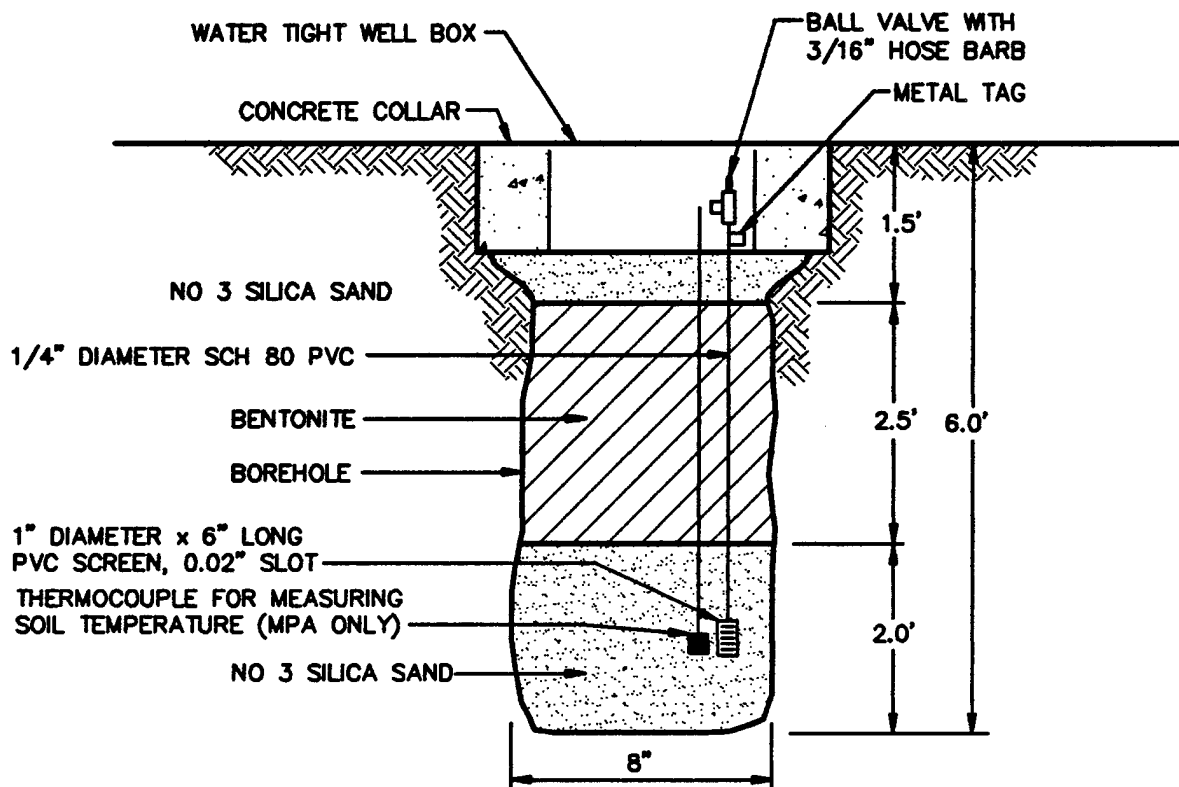
FIGURE 2.4

At Area K, the three MPs (MPA, MPB, and MPC) were constructed as shown in Figure 2.4. A single screen was installed at each MP at 5 feet bgs. Each MP was constructed using a 6-inch section of 1-inch-diameter PVC well screen and a 0.25-inch-diameter PVC riser pipe extending to the ground surface. At the top of each riser, a ball valve and a 3/16-inch hose barb were installed. The top of each MP was

AREA K
AS-BUILT MONITORING POINT
CONSTRUCTION DETAIL

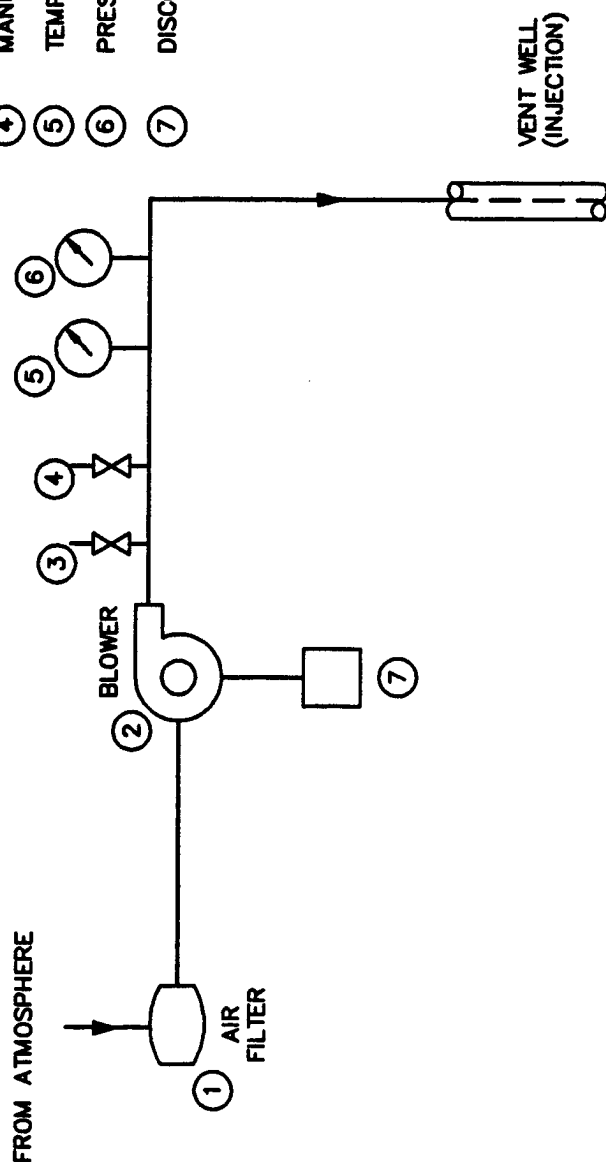
FIGURE 2.5

- ① INLET AIR FILTER- GAST® MODEL AA 905G
- ② 1 1/2 HORSEPOWER ROTARY VANE BLOWER-
GAST® MODEL 2567-P102
- ③ AUTOMATIC PRESSURE RELIEF VALVE-
GAST® MODEL AA307
- ④ MANUAL PRESSURE RELIEF (BLEED) VALVE- 3/4" GATE
- ⑤ TEMPERATURE GAUGE (0-250° F)
- ⑥ PRESSURE GAUGE (0-100 IN H₂O)
- ⑦ DISCONNECT SWITCH- 230V/SINGLE PHASE/20 AMP

AREA K AS-BUILT BLOWER SYSTEM FOR AIR INJECTION

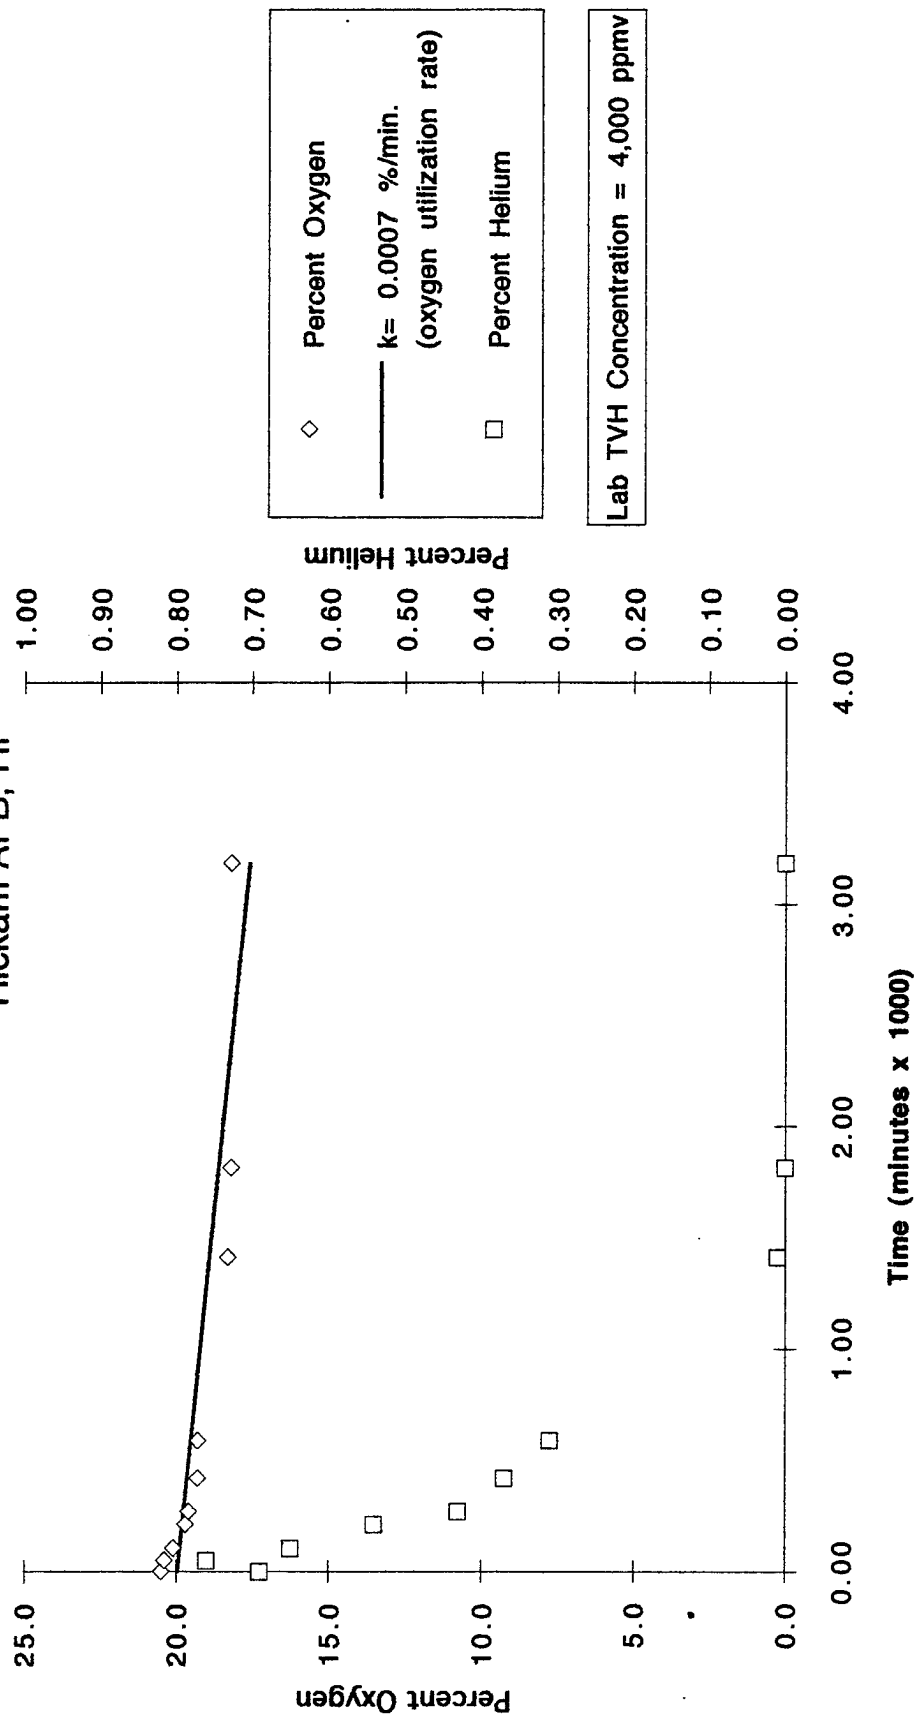
Figure 2.6
Respiration Test
Oxygen and Helium Concentrations
Area K
VW
Hickam AFB, HI

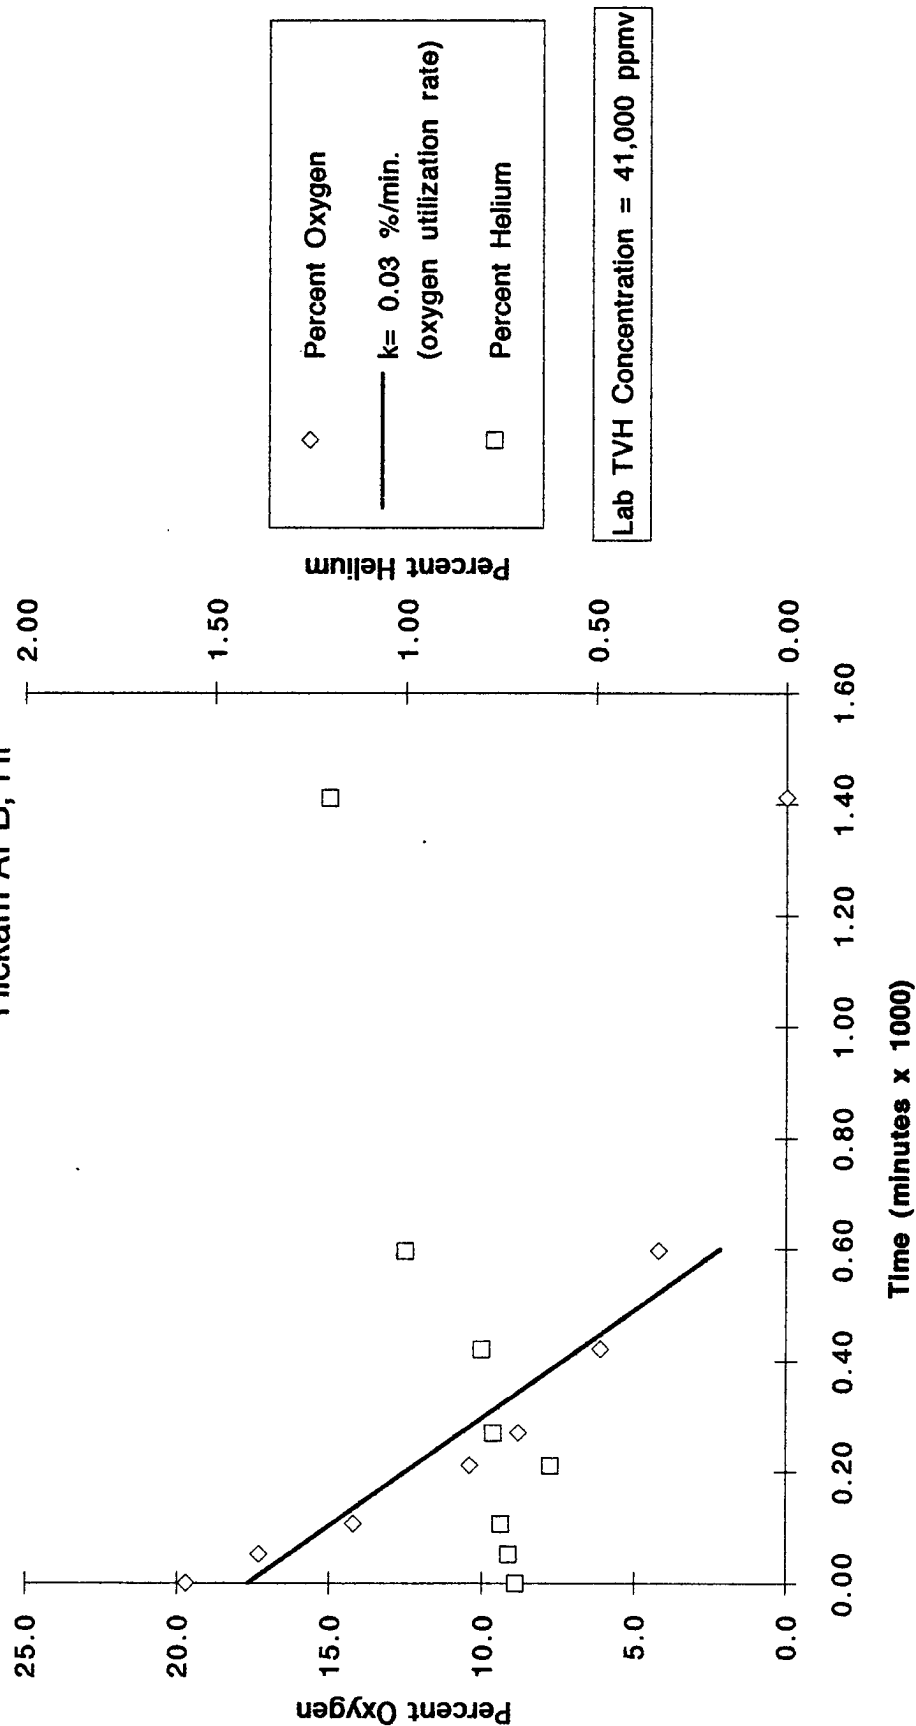
Figure 2.7
Respiration Test
Oxygen and Helium Concentrations
Area K
MPA
Hickam AFB, HI
